# An integrated risk-based inspection approach for enhancing process safety in hydrocarbon storage tanks

Cite this article as: Kahoul H., Hellas M.S., Zerrouki H. *et al.* An integrated risk-based inspection approach for enhancing process safety in hydrocarbon storage tanks. *Sci Rep* (2026). <https://doi.org/10.1038/s41598-026-64995-7>

#### 3.1. Description of the studied system (petroleum storage tank A12)

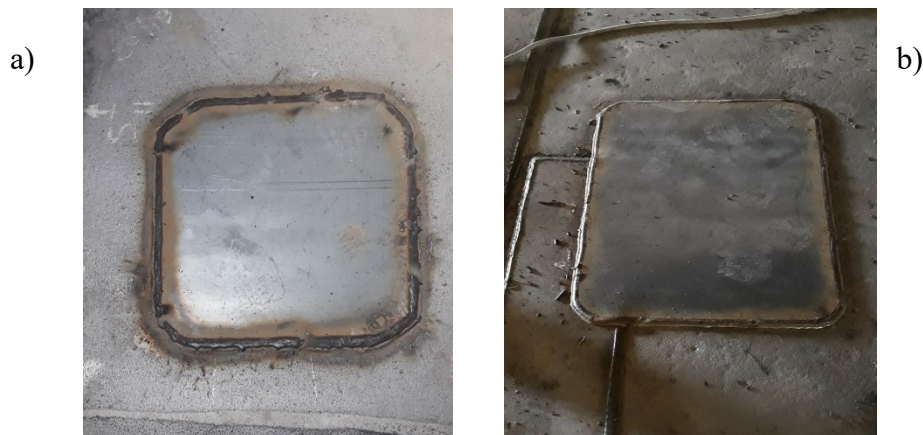
c)  
e)  
**Figure 15**  
bottom

A comparison of measurement results for plates P28, P39, P46, and P49 selected using both methods reveal significant differences between the residual thicknesses estimated via MFL and UT measurements. It can be seen that on average, the MFL system overestimates the defect depth, whereas the ultrasonic method underestimates. Since UT provides a direct, localized measurement of remaining thickness, it is considered more reliable for the quantitative assessment of metal loss. Consequently, MFL can be adopted as a technique for detecting and mapping corroded areas over large surfaces, whereas UT serves as the reference method for validating defect depths and determining actual residual thickness at critical points. Based on the discrepancies observed between the two methods, the UT results were selected for decision-making and the rehabilitation of the bottom Tank A12, as illustrated by the actual repair work shown in Figure 15 (a-f)

The identified localized inner and the bottom external

corrosion on Tank A12 is and affects both the outer surfaces of plates. On the surface, corrosion

is typically electrochemical in nature, initiated by the surrounding soil acting as an electrolyte. Soil corrosivity is governed by several factors, including PH, resistivity, moisture content, and the presence of chloride, sulfide, and sulfate ions, dissolved oxygen, bacterial activity, and stray currents. On the internal surface, corrosion generally originates from water that accumulates at the tank bottom. This settled water can contain highly corrosive agents such as bacteria, dissolved CO<sub>2</sub>, salts, chloride ions, and oxygen, particularly where the protective coating is absent, degraded, or was improperly applied all of which accelerate the corrosion process.

Following this assessment, and in accordance with API 653 requirements, the company developed a repair plan was developed, and the rehabilitation of the tank bottom was subsequently carried out.
